An Investigation of Johnston Vertical Pump Vibration Problem, 2005

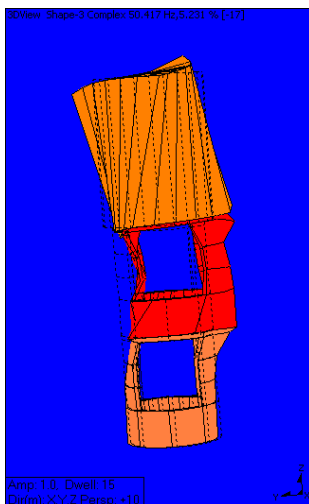
From Modal analysis and FEA, the vertical pump was having its 2nd bending mode at 50.4Hz; 'on-spot' to the running speed of 50 Hz, hence, hitting its structural resonance. The animation clearly showed that the structural movements by this 2nd bending mode was having its anti-node at the thrust pot – discharge head interface assembly that would eventually caused the mechanical seal and other components to wear and leading to the frequent failure of the vertical pump.

Mode shapes @ 50.4Hz

Based from the analyses results, the dynamic design criterion was established as follows; a dynamic design criterion was established that would shift the 2nd bending mode of Vertical Pump away from the running speed up to above 70Hz frequency while ensuring that the twisting mode at lower frequency will not enter into the operating region.

Therefore, the modification is aimed to stiffen the thrust pot – discharge head support structure. Structural Dynamic Modification (SDM) was performed by adding stiffener to the existing thrust pot and discharge head. Performing the proposed SDM has shifted the 2nd bending mode of the pump at to 81.4Hz.

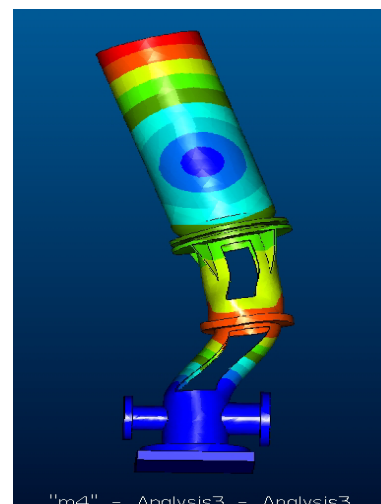
FEA Mode shape@ 51.9Hz
