An Investigation of Johnston Vertical Pump Vibration Problem, 2005

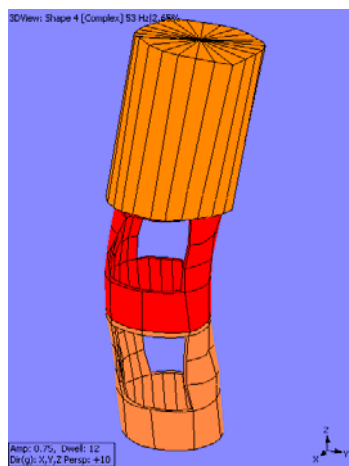
From Modal analysis and FEA, the vertical pump was having its 2nd bending mode at 46.4Hz and 53.0Hz; 'very close' to the running speed of 50 Hz. The animation correlates and clearly showed that the structural movements during operation dominated by this 2nd bending mode was having its anti-node at the thrust pot - discharge head interface assembly that would eventually caused the mechanical seal and other components to wear and leading to the frequent failure of the vertical pump.

Mode shapes @ 46.4, 53.0Hz

A dynamic design criterion was established that would shift both the 2nd bending mode of the Vertical Pump at 46.4Hz and 53Hz, away from the running speed up while ensuring that the 33.9Hz twisting mode will not enter into the Pump operating region

Some modifications were performed on the Vertical Pump thrust pot - discharge head assembly to accommodate interchangeability have shifted the resonance frequency 46.4Hz away from the running speed of 50Hz to 76.2Hz and the twisting mode at 33.9Hz to 36.7Hz.

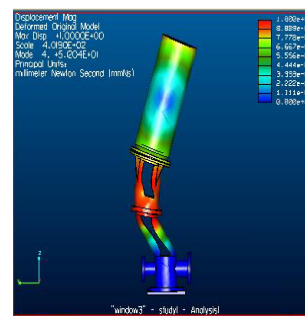
FEA Mode shape@ 51.2Hz
