An Investigation of Johnston Vertical Pump Vibration Problem, 2005

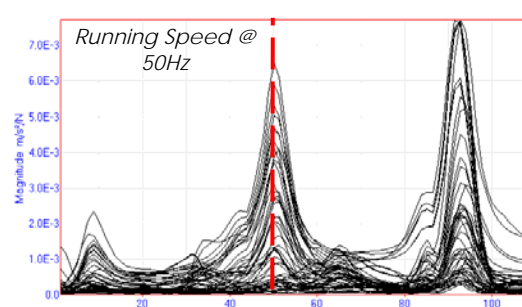
Mode Shape	Modal FRF (Hz)	Modal FEA (Hz) Original	SDM #2 (Hz) (8 ribs stiffeners)
Twisting mode	32.7	34.9	38.3
2 nd Bending mode	50.4	51.9	81.4

FRF Modal spectrums for Johnston Vertical Pump

Therefore, the modification is aimed to stiffen the thrust pot – discharge head support structure. Structural Dynamic Modification (SDM) performed by adding 8 rectangular and tapered rib stiffener to the existing thrust pot and discharge head. Performing the proposed SDM has shifted the 2nd bending mode of the pump at 50.4Hz up to 81.4Hz; while the twisting mode at 32.7Hz to 38.3Hz.

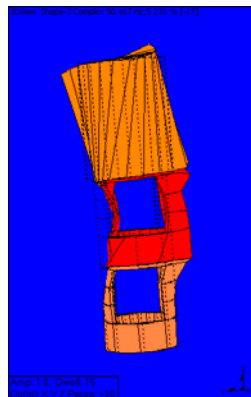
From Modal analysis and FEA, the vertical pump was having its 2nd bending mode at 50.4Hz; 'on-spot' to the running speed of 50 Hz, hence, hitting its structural resonance. The animation clearly showed that the structural movements by this 2nd bending mode was having its anti-node at the thrust pot – discharge head interface assembly that would eventually caused the mechanical seal and other components to wear and leading to the frequent failure of the vertical pump.

Mode shapes @ 50.4Hz

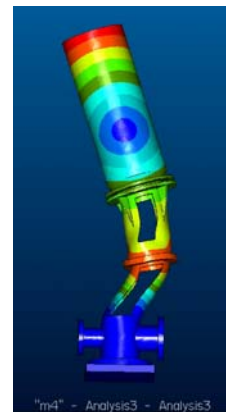
FEA Mode shape @ 51.9Hz
