An Investigation of 2 units of Gas Lift Reciprocating Compressor High Vibration Problem at South Angsi Platform, Off-shore Kerteh Terengganu, 2008

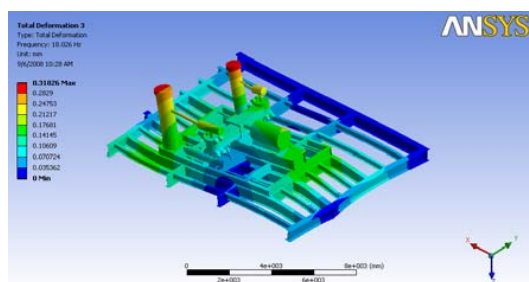
In FRF modal analysis, it is found that the significant modes are in the region of 14Hz (1st bending mode about the axis of shaft) and 18Hz (2nd bending mode about axis perpendicular to the shaft line). The 18Hz mode is very close to the running speed of the compressor (16.7Hz). The ODS of compressor at 16.7Hz confirmed the motion to be very close to the mode shape of the compressor at 18Hz. This problem is classified as structural dynamic weakness or resonance.

Finite Element Analysis (FEA); Modal analysis and stress analysis was performed and correlation was established between both measurement and computational techniques. From the analyses, structural dynamic modifications were performed by introducing additional beams and plate below the skid for both the train. The aim is to shift the 18Hz mode to a higher value while maintaining the frequency of the 14Hz mode not to allow it to creep into the running speed of the compressors. Performing these modifications would shift the 18Hz mode to about 20Hz and 14Hz to about 15Hz. However, due to its high mass, large amount of stiffening is required to shift the natural frequencies.

FE Modal Results for Reciprocating Compressor
