An Investigation of Main Oil Line Pumps Problems on the Dulang-B Oil Platform, Offshore Kerteh, Terengganu, 1998

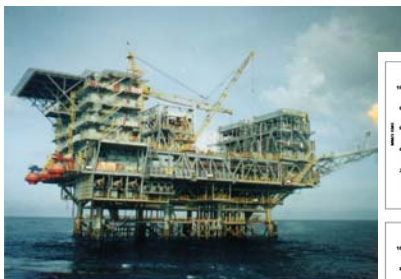
Spectral Trending

Trending of the 1X and 0.4X frequency components showed the 0.4x component tend to increase rapidly prior to mechanical seal failure while the 1x component dropped. The magnitude of the two frequency components (1x and 0.4x) tend to swap with each other on the approach of shaft failure.
