**An Investigation of Reciprocating Compressor High Vibration Problem at PPMSB, Sungai Udang, Melaka, 2008**

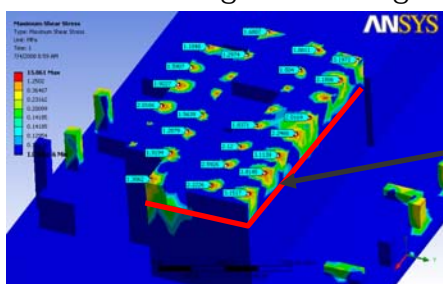
Further simulation to simulate the effect of ineffective bolts as well as the crack length using FEA Stress Deformation Analysis indicated that 1st crack line most probably originates from the sharp corners of the foundation where the foundation experiencing shear stress due to the “pull & push” movement of the compressor. Combined dynamics movement of the compressor and its gravitational load result in tensile stress occurring in the region where 2nd crack line.

Based on analyses results, the depth (crack length) of the 1st crack line has more effect on the compressor displacement as compared to 2nd crack line. Unit-B has almost 6 ineffective bolts as compared to about 3 bolts for unit-A.

Maximum stress contour in FEA

Therefore, for long term counter-measure, it was recommended to the vibration monitoring unit to include vibration monitoring at this location (in displacement) and perform amplitude trending as part of their foundation inspection procedure. As for the “loose-bolts” for unit-B, it was to be rectified during the next planned shutdown, while monitoring the crack growth of unit-A.
