An Investigation of Structural Vibration on Main Oil Line Pump at Tiong-A Platform, Offshore Kerteh, Terengganu, 2000

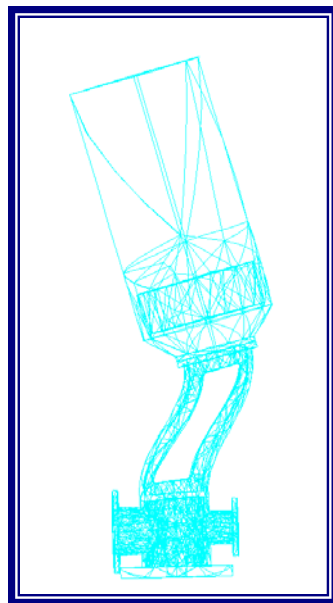
From Modal analysis and Finite Element analysis on the GE Motor and the US Motor, it is concluded that the natural frequency of GE Motor at 56 Hz (second bending mode) was the root cause of the frequent failure. The US Motor was having a higher natural frequency of the second bending mode at 73 Hz – which is sufficiently away from the running speed (60Hz). Thus, the US Motor does not suffer from resonance problem.

FEA Result of MOL pump with GE Motor @ 56.6Hz – 2nd Bending Mode

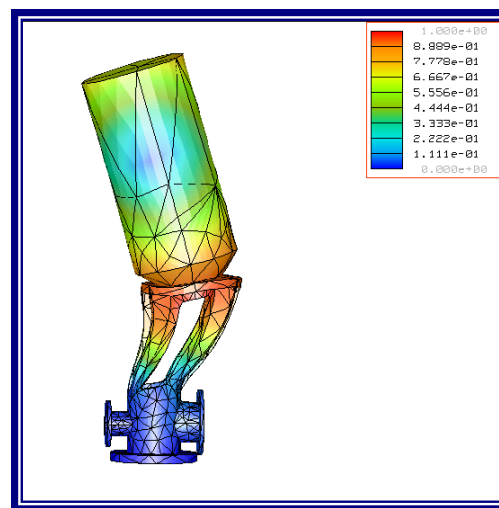
FEA Result of Modified MOL pump assembly with GE Motor @ 97.3Hz– 2nd Bending Mode

It is strongly recommended that for the GE Motor to be utilized, structural dynamic modification had to be performed on the discharge head to shift the natural frequency of the second bending mode away from the running speed. This modification on the discharge head shall only be used with GE Motor. The structural dynamic modification is performed using Finite Element Analysis and the detail engineering drawings are attached for further actions. The modification is performed using six 2.54cm thick ribs being welded to the bottom of the discharge head column and the ring at an angle of 74.5°. The 2.54cm thick ribs has shifted the second bending mode from 56.6 Hz to 97.3Hz which is already far from the running speed without disturbing the twisting mode natural frequency at 31Hz.
