An Investigation of Structural Vibration on Reciprocating Compressor, 2000

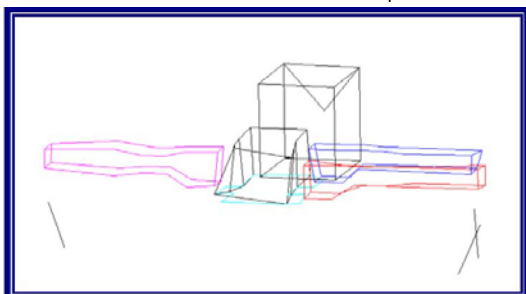
Operating Deflection Shape Analysis has identified the location of high vibration on the three units of compressors leading to cracks at the grouting, holding bolts looseness, and lubrication oil leakage. The results indicated that the main source of excitation came from the 3rd stage cylinder, causing the crankcase to be twisted and oscillates vertically. The twisting of crankcase later forced the 2nd and 3rd stage to swing in horizontal y-direction pivoted at the cross-head section.

Operation Deflection Shape for all Components investigated on Reciprocating Compressor

Stiffening all the 3 cylinders to restrain its movement would be the solution to avoid further damage to the entire machine. It requires further discussion for a proper stiffening method due to limited space to the ground. Most importantly, end users managed to re-solve dispute among manufacturers and the main contractor as to whom should be responsible on the crack grouting issue.

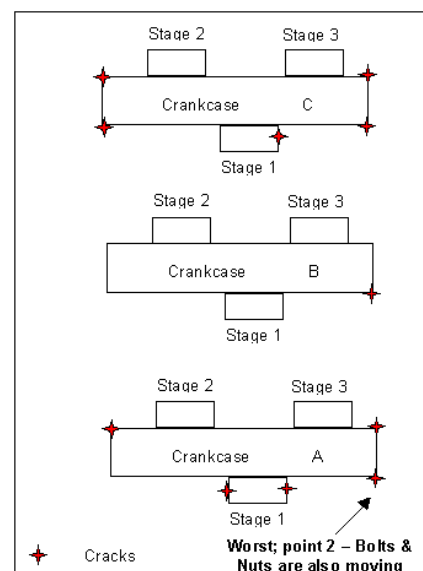
Crack locations observed at all three Reciprocating Compressors, Unit A, B and C

It is recommended that monitoring and trending should be done in displacement, μm to eliminate the high frequency harmonics; having a more meaningful information from the spectral plots. Visual inspection of the gaps, bolts and the cracks should be part of the monitoring procedure. If any sudden change in the gradient of the vibration trending curve and rapid growth of cracks on the grouting, then the machine should be stopped. It is also vital to check the allowable gaps of the journal bearing at the non-drive end side of the crankcase. Maximum deflection recorded at the crankcase should be less than the gaps in-between the journal bearing. Exceeding the allowable gaps will lead to other secondary problems such as knocking of the journal, whirl and whip and etc.
