An Investigation on Air Fin Fan Blade Failure on ID Fan, 2000

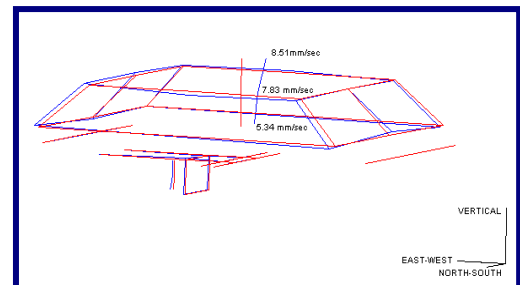
Operating Deflection Shape at 14.75 Hz showing shaft movement mainly in East-West direction

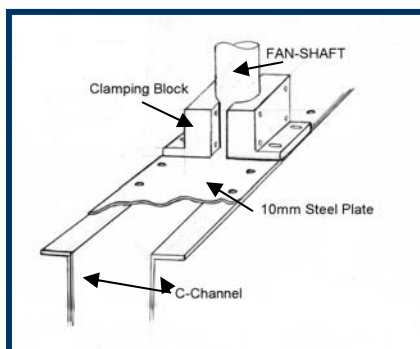
Sketch of the recommended modification on the C-channel

It is recommended that the two C-channels supporting the whole fan-shaft, motor and pulley should be stiffen with a 10-mm thick steel plate bolted to the top and bottom of the channels. Additional to the bearing assembly, which is the only thing that holds the entire fan, it is recommended to fabricate another clamping device as to holds it at two points.

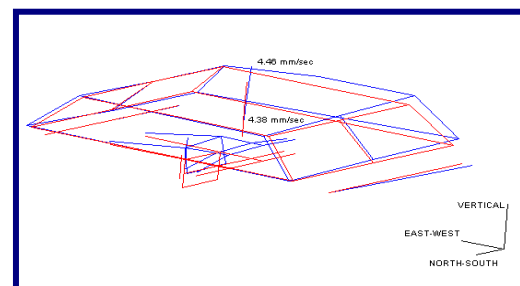
It is concluded that the root cause of the repeated failure of the Air Fin Fan Cooler Blade was due to the weaknesses of the supporting structure inducing harmonics of the fan-shaft running speed of 2.9 Hz (174 rpm). Operating Deflection Shape (ODS) analysis showed that dominating frequency at the fan-shaft was found to be a combination of the 4th and 5th harmonics (11.75Hz/705rpm) and 14.75 Hz/885 rpm respectively. This has excited the 12Hz fan blade-bending mode that creates a cyclic bending stress on the holding bolts. Simulation of the actual movement while in operation shows that the fan-shaft is vibrating at 8.51mm/sec peak in East-West direction (elliptical shape) which is perpendicular to the supporting C-channel. These had resulted in a relative angular velocity of 11.9Hz in the fan-shaft movement that imposed a cyclic bending stress on the holding bolts. The C-channel is vibrating in a bending mode at 11.75Hz (4th harmonics of the running speed).

Operating Deflection Shape at 11.75 Hz showing fan-shaft and C-channel bending in vertical direction.
